# Key Components, Tegholmen Works

## MC fuel pump

# Latest Design for 80-98 bore MC/-C engines

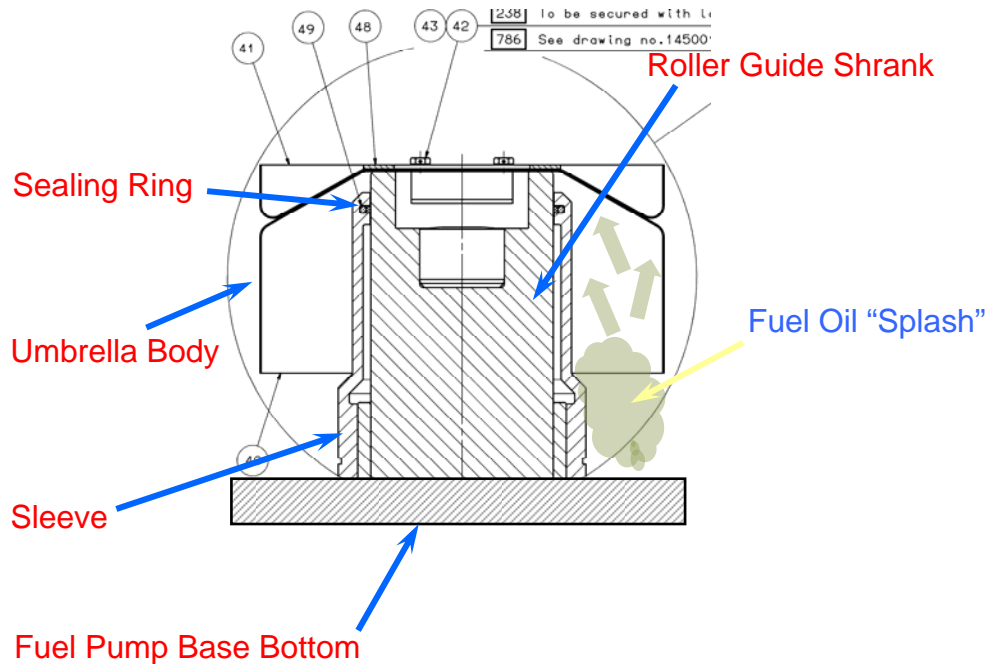
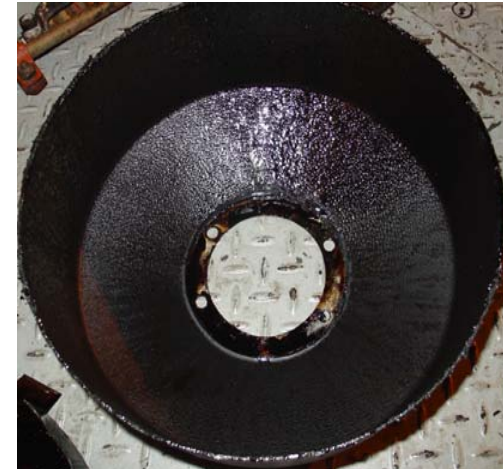
Fuel on lower surface of umbrella caused by splash from pump base bottom

Leaking fuel oil from the plunger/barrel assembly enters the fuel pump base bottom. Pressure variation within the pump base block during up and downwards movement of the umbrella lead to splash of fuel oil as indicated

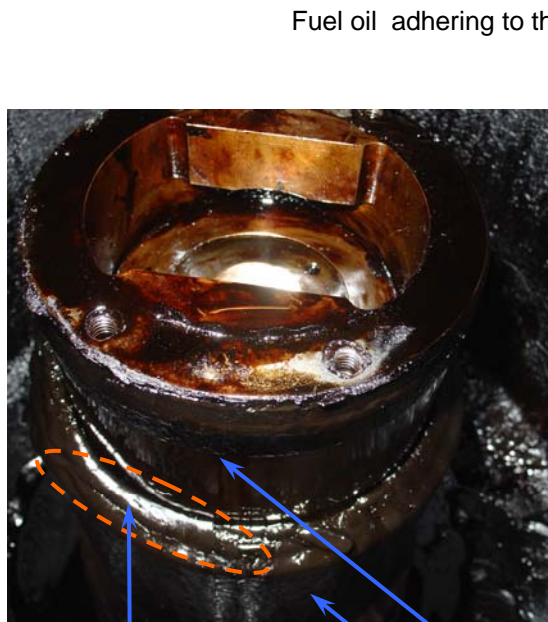
Fuel oil adhering to the surface

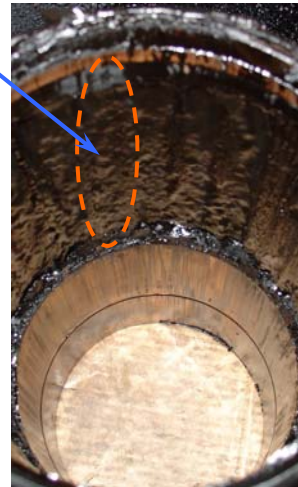
Inner surface of the sleeve

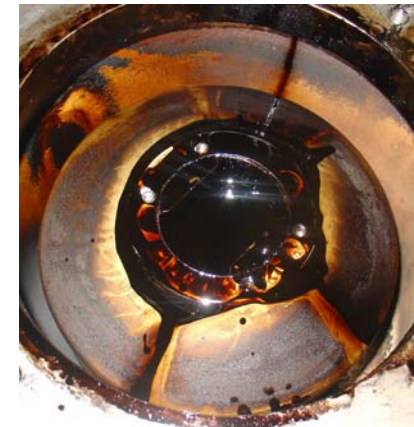
Umbrella seen in the pump base block

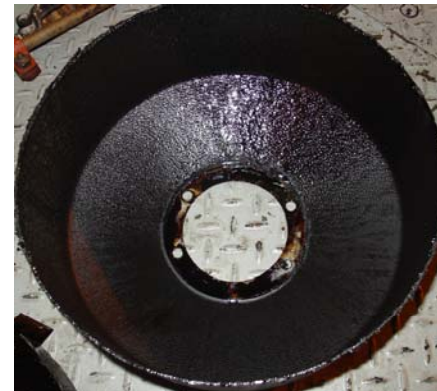
Lower umbrella seen in the pump base block

The umbrella diameter occupies the majority of the pump base block cross section. This may lead to pulsation of air and fuel oil splash within the pump base block.

- Consider introduction of holes in vertical umbrella parts where through the pulsation of air can equalize. This may stop the fuel splash.

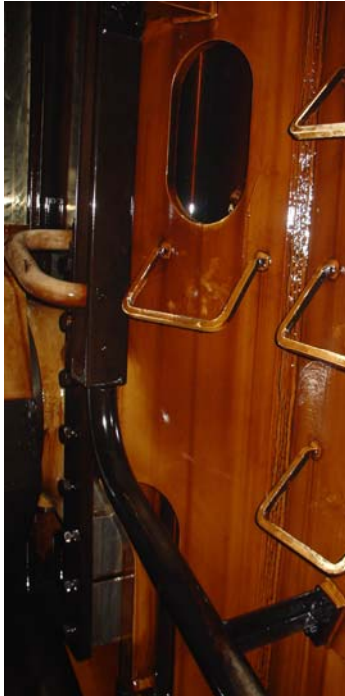
Discolouring of crankcase structure

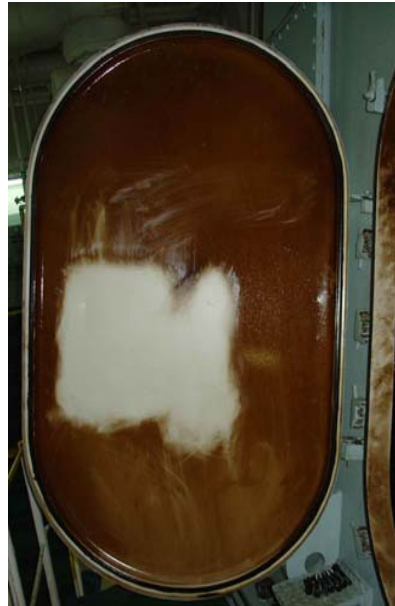
Deposit of Copper, Sulphur and additive components (phosphorus, calcium and zinc)

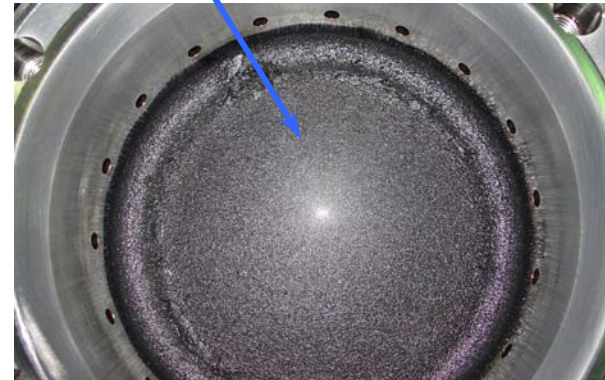
Deposit on piston crown cooling space surface

Despite no trace of Asphaltene components in the deposit being analyzed experience shows, that the deposits are formed rapidly, when Asphaltene is found in system oil samples

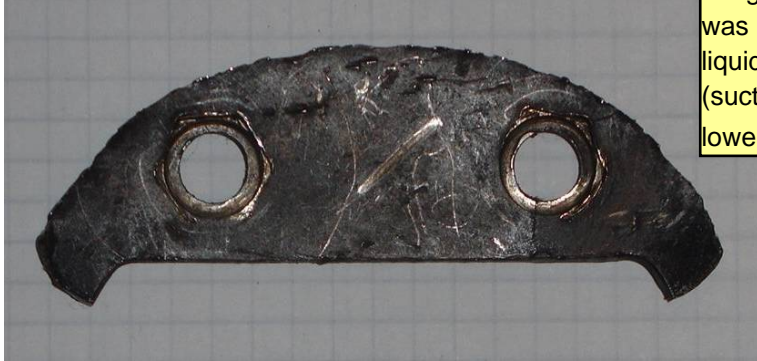
Fatigue breakage of the umbrella top part was initially expected to be related to liquid shock during downwards movement (suction stroke), if fuel oil was collected in lower part of the pump base block

Besides impact from liquid shock sufficient free space below the umbrella body (picture below) has been checked. With the distances shown in the picture no risk, that the umbrella body parts can touch the lower pump base block, is present.

- Scheduled inspection of the umbrella assembly (fatigue cracks etc.) and the sleeve (correct shrink fit)
- Scheduled inspection/replacement of umbrella scraper rings

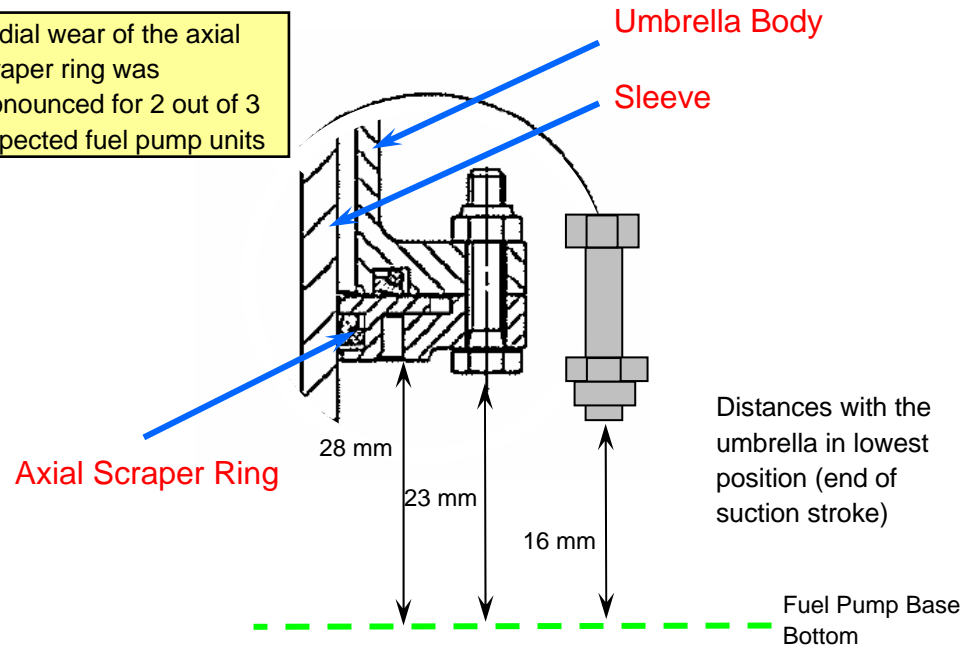
Radial wear of the axial scraper ring was pronounced for 2 out of 3 inspected fuel pump units

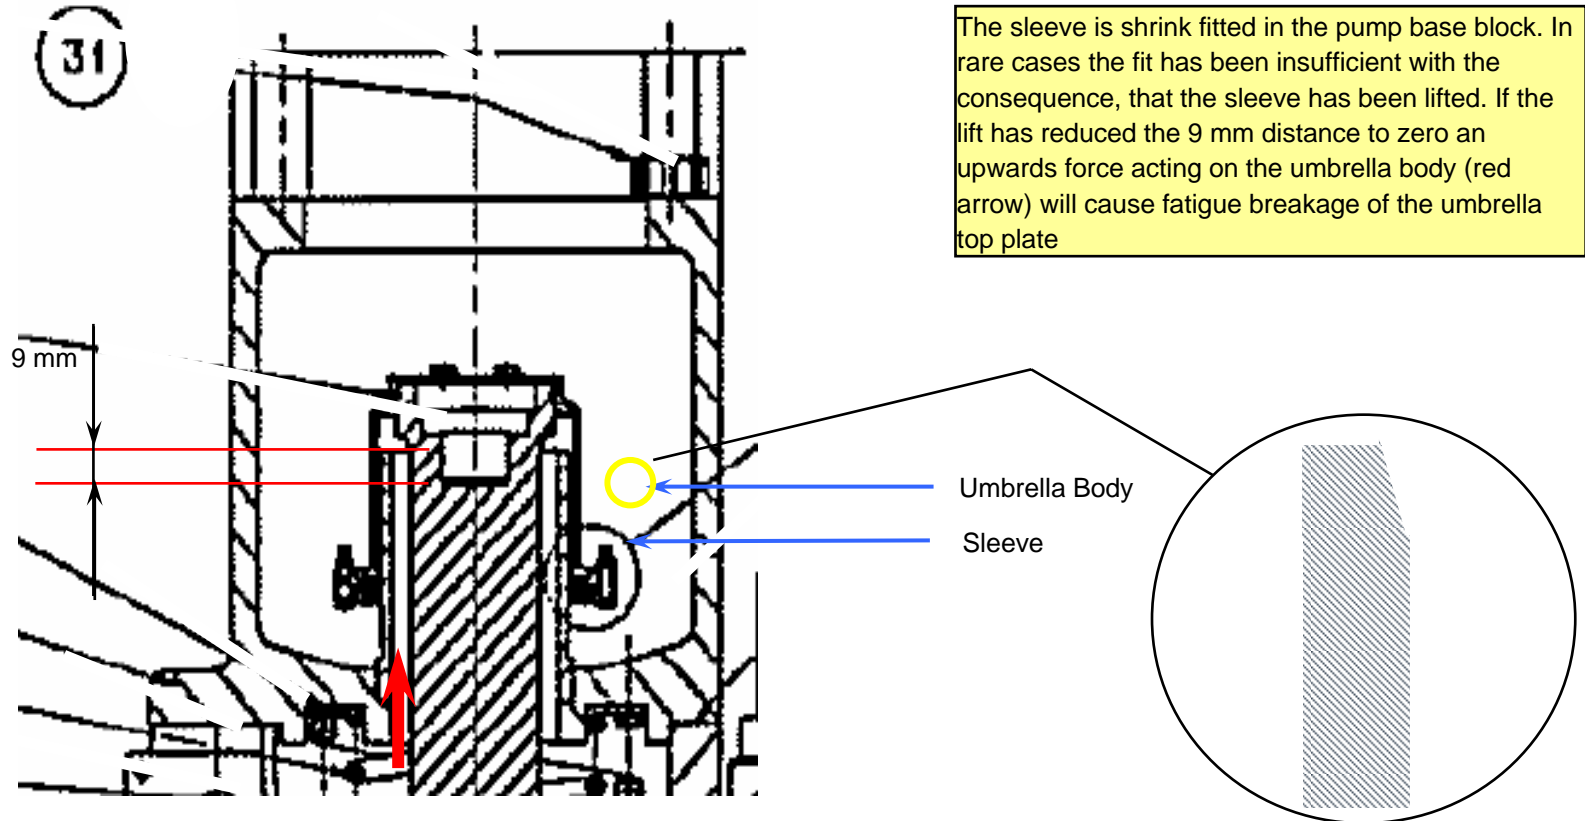
The sleeve is shrink fitted in the pump base block. In rare cases the fit has been insufficient with the consequence, that the sleeve has been lifted. If the lift has reduced the 9 mm distance to zero an upwards force acting on the umbrella body (red arrow) will cause fatigue breakage of the umbrella top plate

The taper shape of the top of the sleeve was insufficient to prevent damage to the sealing ring edges during assembly

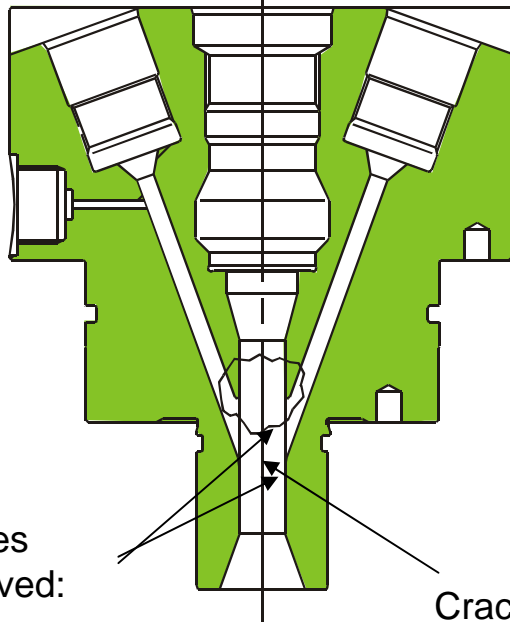
**Previous**

Crack initiation area

The fractures have been experienced on small and medium bore engines. The fractures were initiated at the position where the inclined drillings for the high-pressure pipes intersect with the central bore. The cause of the failure has in all cases been related to roundings which did not fulfil our specifications.

The cracks are initiated at the edge between the central bore and the inclined bores, due to the lack of the specified manual finishing of the transition edge between the central bore and the inclined bore. The crack-initiated area is shown in Fig. 1.

We recommend checking whether the spare cover is of the original design. If this is the case, please check the transition between the vertical bore and the inclined bores. The transition area must have a radius of min. 0.5 mm. On the spare top cover, the sharp edge must be removed and a rounding of min 0.5 mm must be made.

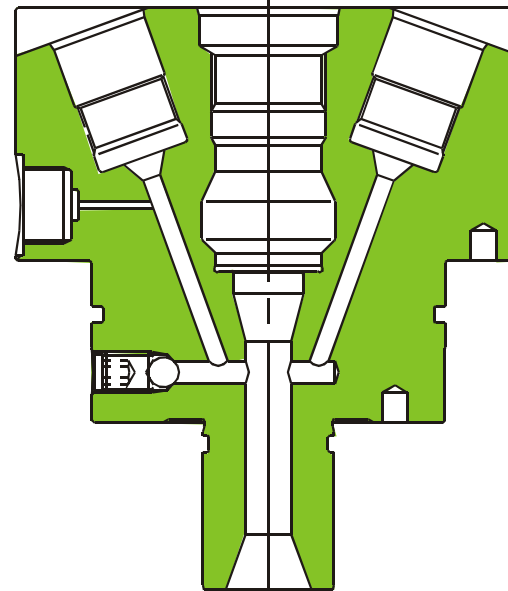
**New**

Sharp edges  
to be removed:  
R1-R10

In order to eliminate the need for manual finishing during production, and as an alternative to this, we have introduced a modified design for future top covers. The design is shown in Fig. 2.

The modification involves the introduction of a horizontal bore connecting the vertical central bore and the inclined bores.

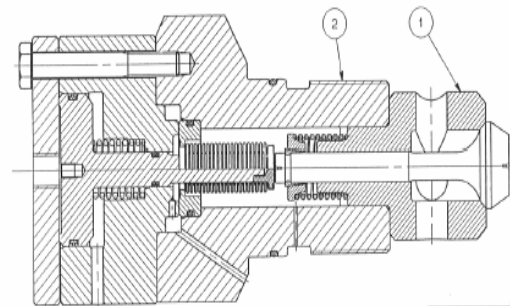
Due to cracked bellows, the design has been changed.

Previous design with bellows

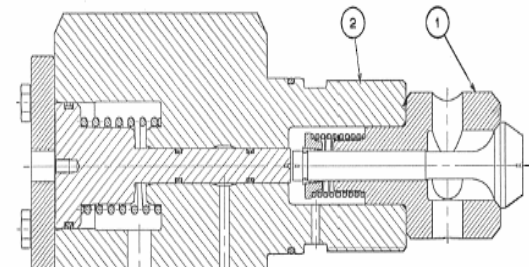
Modified design w/o bellows

Unit item 2 from modified design is interchangeable with unit item 2 from previous design.

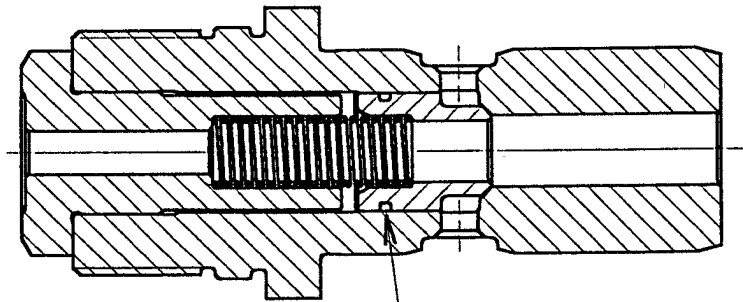
ORIGINAL SUCTION VALVE  
FOR Mk 3 & 5 FUEL PUMP  
WITHOUT UMBRELLA

We have recently experienced incidents in which damage has occurred to the sealing ring on the fuel pump suction valve slide.

SEALING RING TO BE REMOVED  
ON ENGINES IN SERVICE

The results of these tests revealed that the suction valve can operate satisfactorily without the sealing ring, and we therefore recommend that the sealing ring be removed at the next suction valve overhaul.

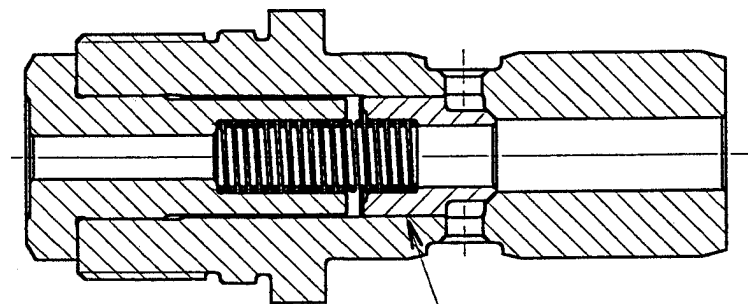
NEW SUCTION VALVE  
FOR Mk 3 & 5 FUEL PUMP  
WITHOUT UMBRELLA

SLIDE WITHOUT GROOVE  
AND WITH REDUCED CLEARANCE

As for future spare parts deliveries, this suction valve slide will be specified without the sealing ring groove, and with a slightly reduced clearance between the slide and the valve housing, please see Enclosure 1.

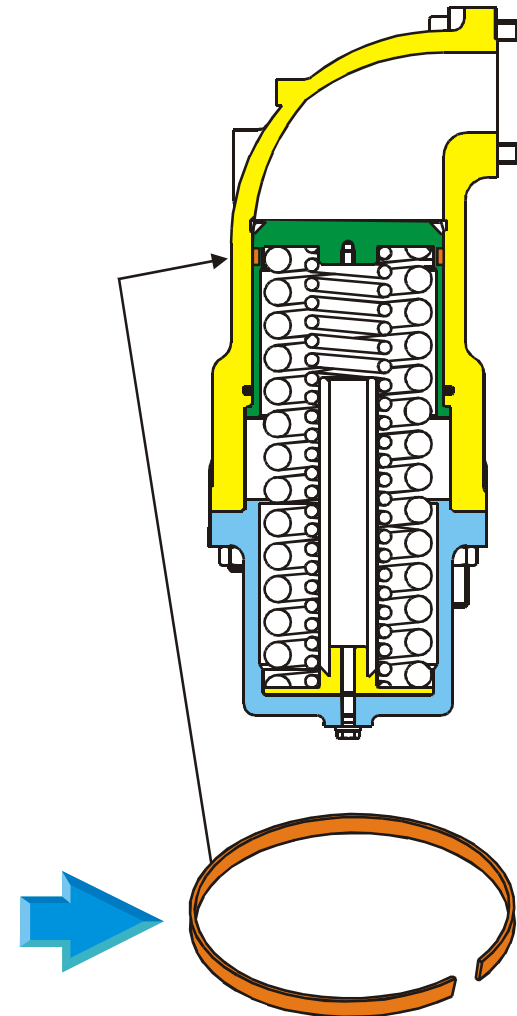
In a few cases cracks have appeared in the sealing ring groove of the housing

In certain cases the guide ring acts as a tight sealing ring because the high running temperature reduces the ring gap to almost nothing

A pressure of approx. ten times the normal working pressure is then built up, hence causing the cracks

The problem was solved by exchanging the guide ring with a new ring with larger gap

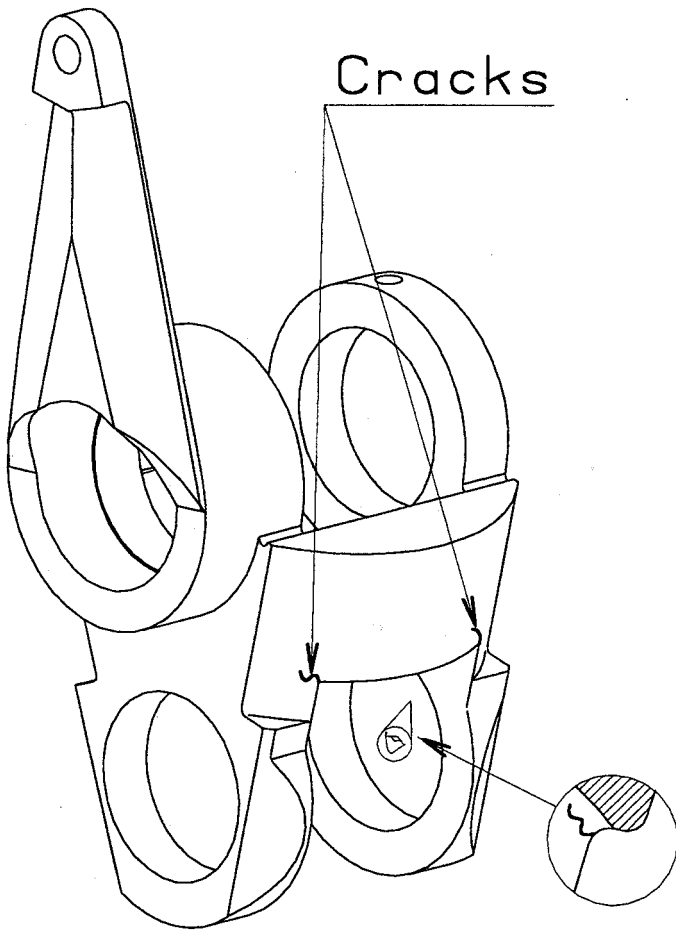
Figure B

The cracks as shown in Fig. B have mainly been found on the K90MC/MC-C types, Mark V or VI, and they were found after a relatively short time in service. The type of cracks indicated in Fig. A have only been reported in a few cases.

The cracks in Fig. B have primarily been located on the camshaft side and can be detected through the inspection cover in the camshaft housing. We recommend that, as a general precaution, you instruct your crews to inspect the reversing link at the first opportunity.

If cracks are detected, we ask you to make a sketch of the extent of the cracks and forward it to the engine builder or MAN B&W Diesel, Copenhagen and, at the same time, to order replacement reversing links. The new reversing links are modified with larger roundings in the relevant areas.

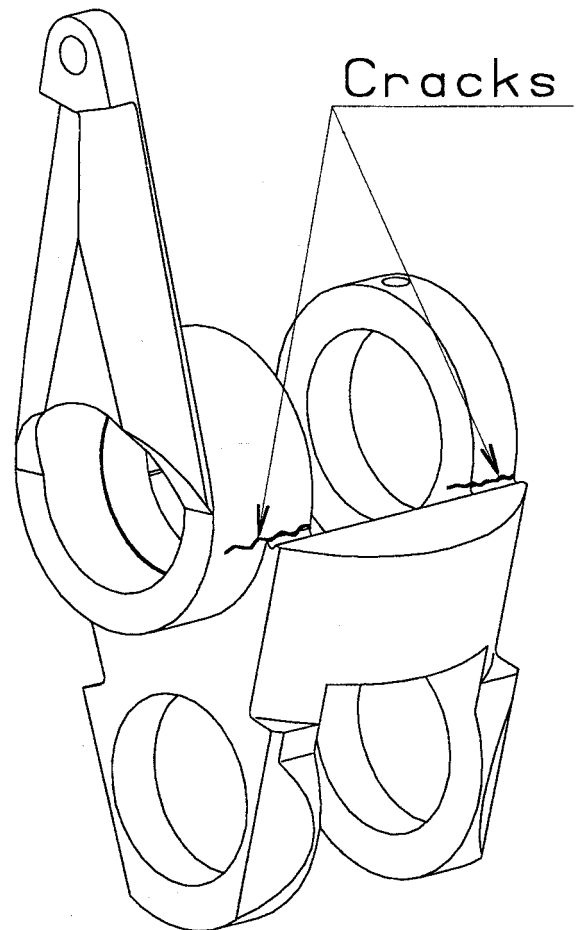
Figure A

Even if no cracks as shown in Fig. B are detected, it is still recommended to inspect for the types of cracks shown in Fig. A, when convenient. It is necessary to pull out the roller guide in order to do this.

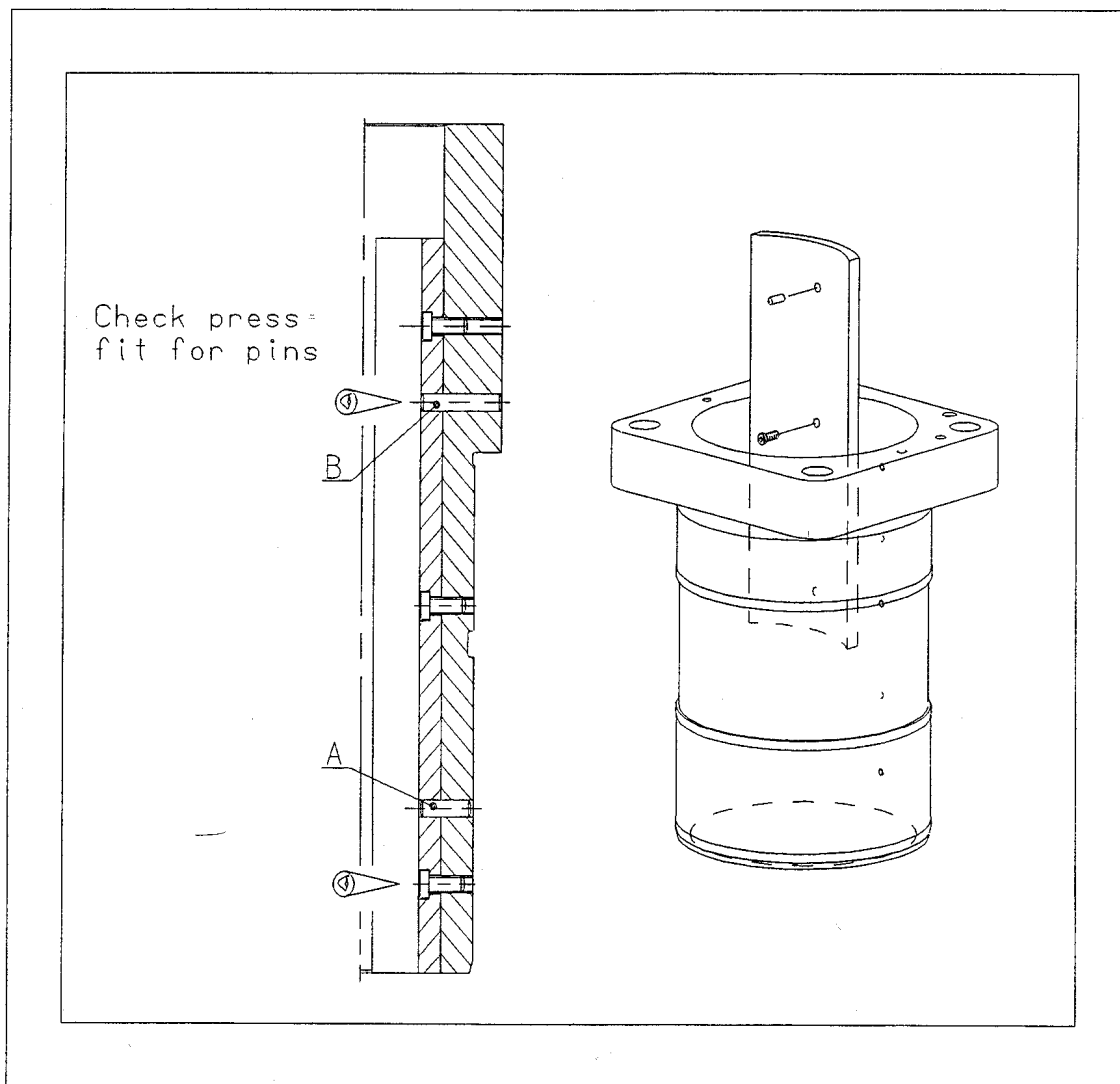
Furthermore, we want to draw your attention to another subject which should be considered in connection with the above recommended inspection of the reversing links. We have received a few reports regarding loose guide blocks for the fuel pump roller guide, see Enclosure 2. Therefore, when checking for cracks in the reversing link, we recommend that also the guide blocks are checked at the same time to see whether they are loose. This can be done when pulling the roller guide.

To improve the fixing of the guide blocks, it must be ensured that the guide pins are inserted in the holes with a tight fit. Furthermore, when new screws are mounted, these should be tightened to the torque indicated in Encl. 2, and locked with Loctite. The new screws should not be locked by caulking, as hitting the screw head improperly, could lead to a reduction of the tightening force of the screw.

1. Dismantle the old screws.
2. Check that the dowel pins are not damaged. If they are damaged, re-check the alignment of the guide block.
3. Check that it is possible for the new screw to seat properly in the old hole in the guide block.
4. Mount the new screws after soaking their threads with Loctite 222. **Note:** It is necessary to degrease the threads.
5. Mount the screws, starting with the lowermost screw.
6. After tightening the top screw, retighten all the screws to the specified torque.
7. Tightening torque: *See enclosed table, Enclosure 2.*
