Cylinder liner variations

Cylinder liner, 98MC/MC-C

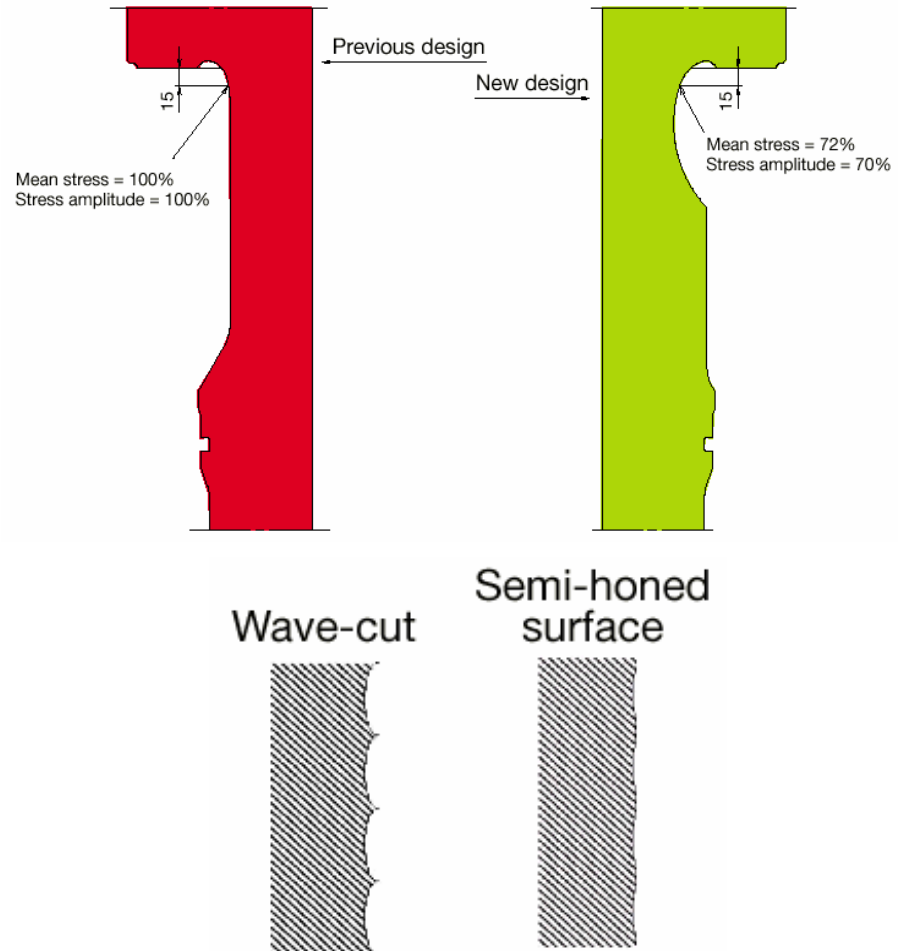
Original design

Expected lifetime 80,000 hours.

MD-C produced liner

- Always made according to latest design
- Lower part of liner has been modified to reduce mean stress and stress amplitude
- Wave-cut and semi-honed surfaces

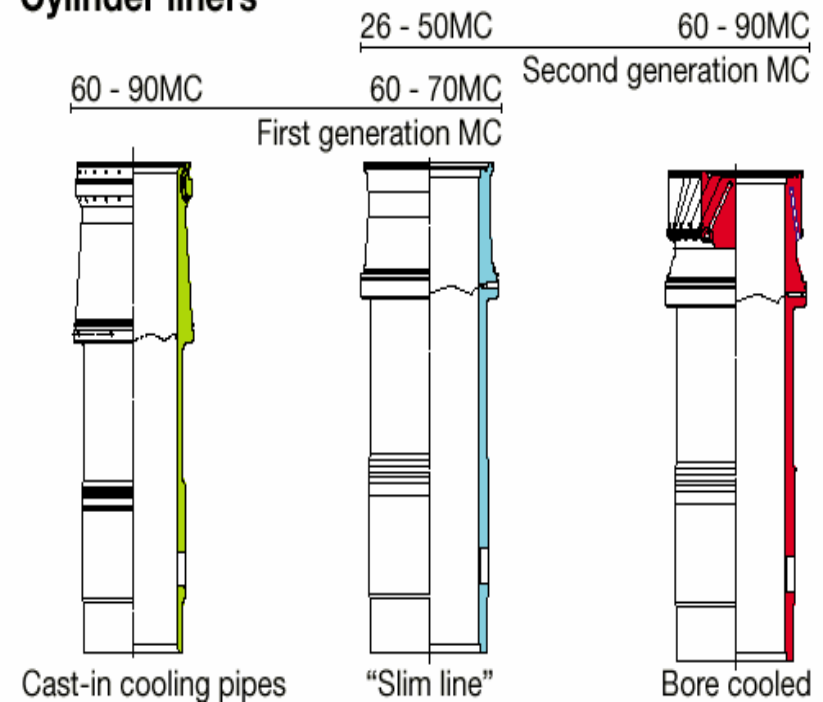
Cylinder liner 90MC/MC-C, 80MC/MC-C

Original design

90MC/MC-C expected lifetime 80,000 hours.

80MC/MC-C expected lifetime 70,000 hours.

Liners produced by MD Copenhagen

Always made according to latest design.

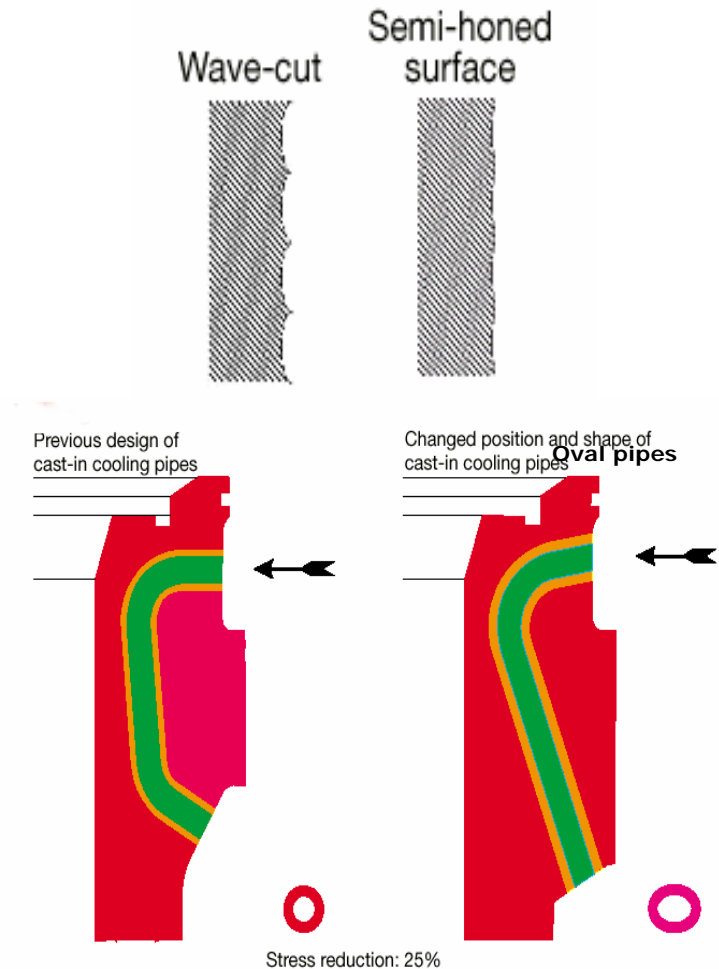
Cylinder liners

MD-C produced liners

All types with wave cut and semi-honed surfaces.

Cast-in in cooling pipes with oval cross-section and one bend.

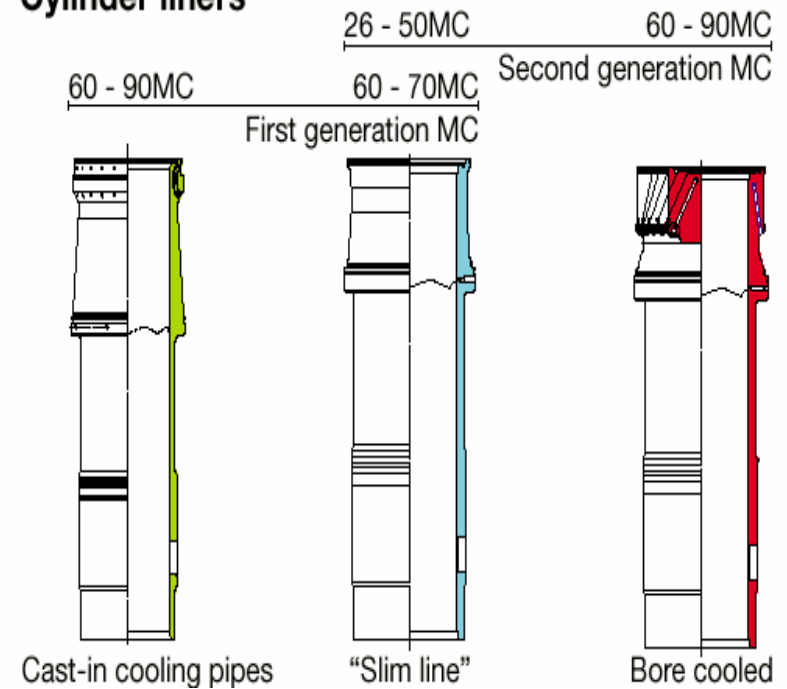
Cylinder liner, 70 MC/MC-C, 60 MC/MC-C

Original design

70 MC/MC-C expected lifetime 70,000 hours.

60 MC/MC-C expected lifetime 60,000 hours.

MD-C produced liners

Always made according to latest design.

Bore-cooled liner with correct number of cooling bores
(increased from 24 to 30 for S type).

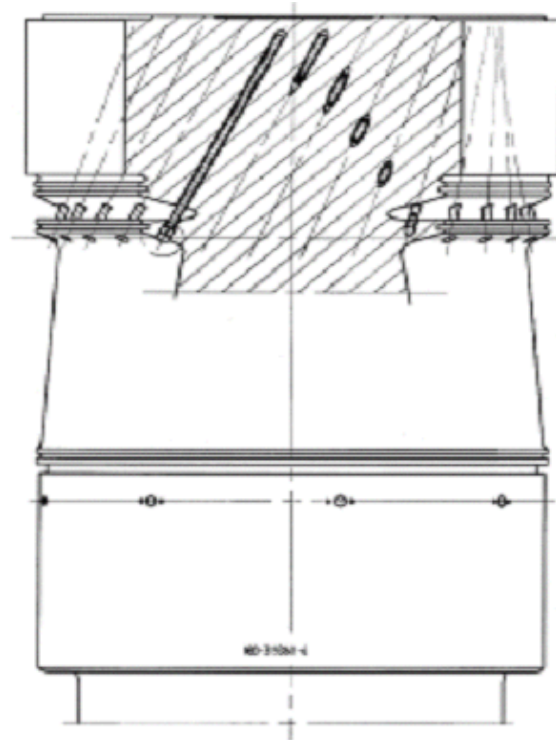
Cylinder liner for S70MC-C

The number of cooling bores have been increased from 24 to 30

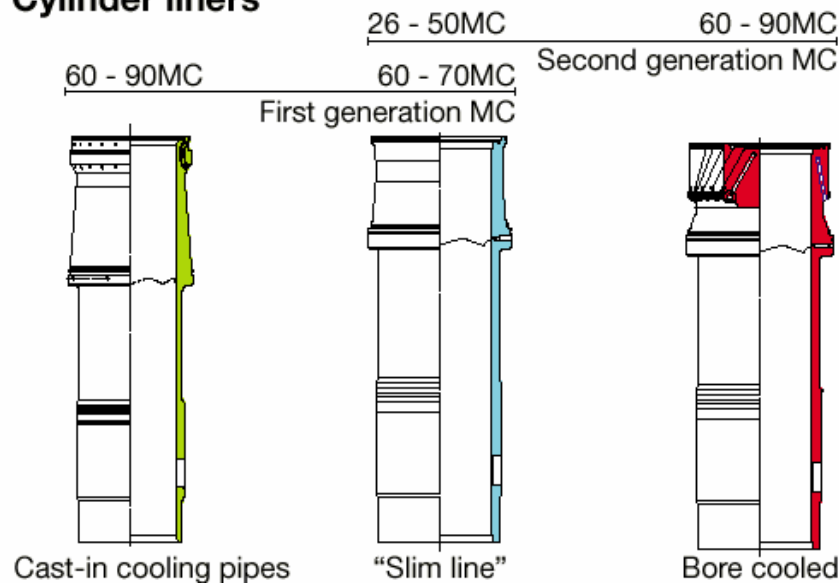
Cylinder liners, 50 MC/MC-C, 46 MC/MC-C, 42 MC, 35 MC, 26 MC

Original design

50MC/MC-C:

Expected lifetime 60,000 hours

46MC/MC-C, 42MC, 35MC:

Expected lifetime 50,000 hours

26MC:

Expected lifetime 40,000 hours

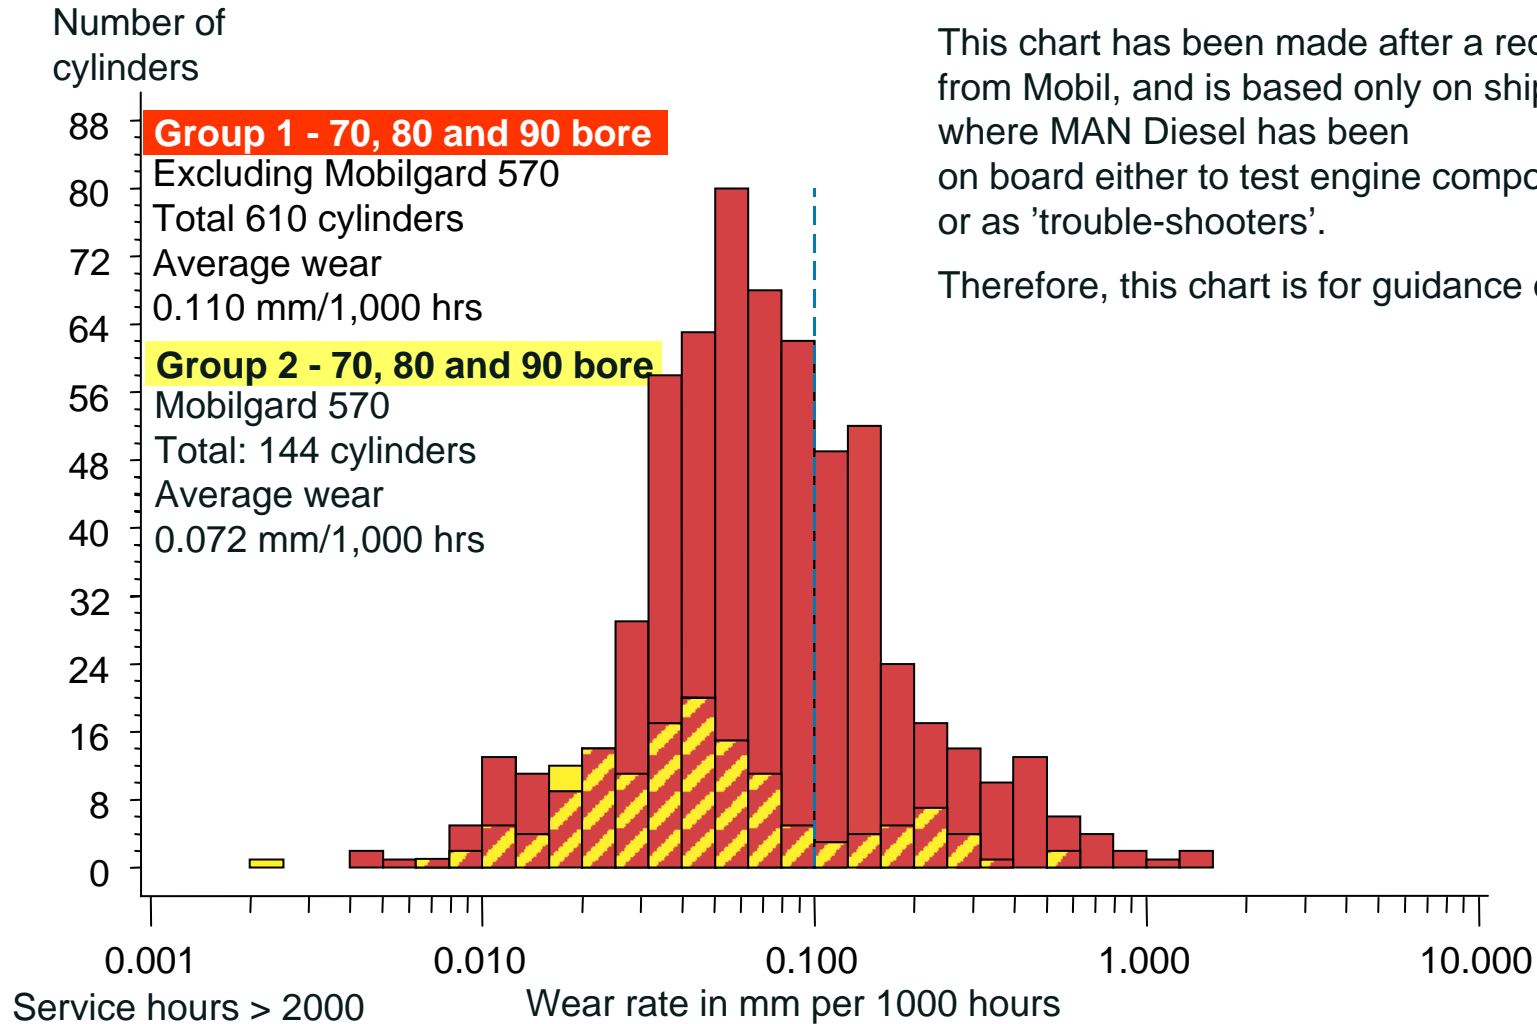
Cylinder Liner Wear Rate – MC-engines

This chart has been made after a request from Mobil, and is based only on ships where MAN Diesel has been on board either to test engine components or as 'trouble-shooters'.

Therefore, this chart is for guidance only.

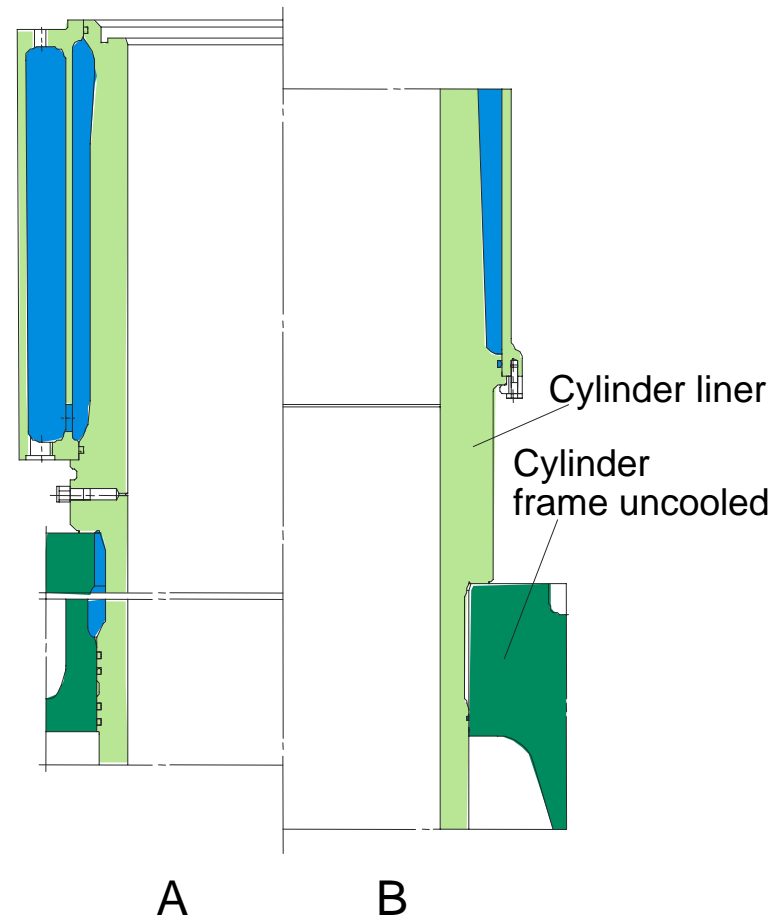
Cylinder Liner and Cylinder Frame

A: Previous design

Cold corrosion on cylinder liners has been experienced in some cases

B: New design

Using an uncooled cylinder Frame, the temperature on the running surface has been increased in the lower part of the cylinder liner by about 60°C

Good experience
The general cylinder condition is improved

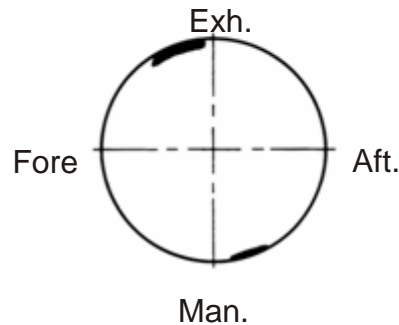
C
Blow-by crack:

Position of C-crack approx. between lowermost ring and skirt upper edge.

Two upper rings have lost tension and are possibly also broken.
Furthermore, ring Nos. 3 and 4 might be sticking.

Points to be checked/modified:

- Performance (VIT, TC)
- Atomizers (small holes, rounded inner edges)
- Modified piston ring material
