# MAN Diesel ATUC TC Information

# Atuc Turbocharger Service Information Content

1. Internal Recirculation IRC
2. TCA 88-25 type approval
3. Lube Oil system and bearing for the TCA series
4. Experience with TCA blades
5. Silencer modification
6. Additional customer informations
7. TCR lube oil supply

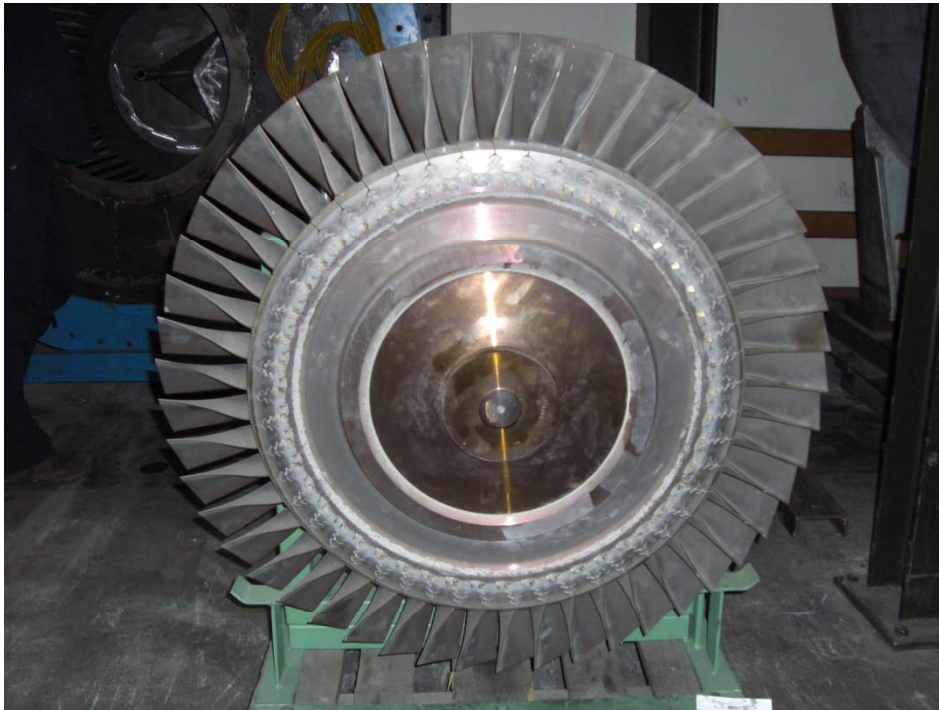
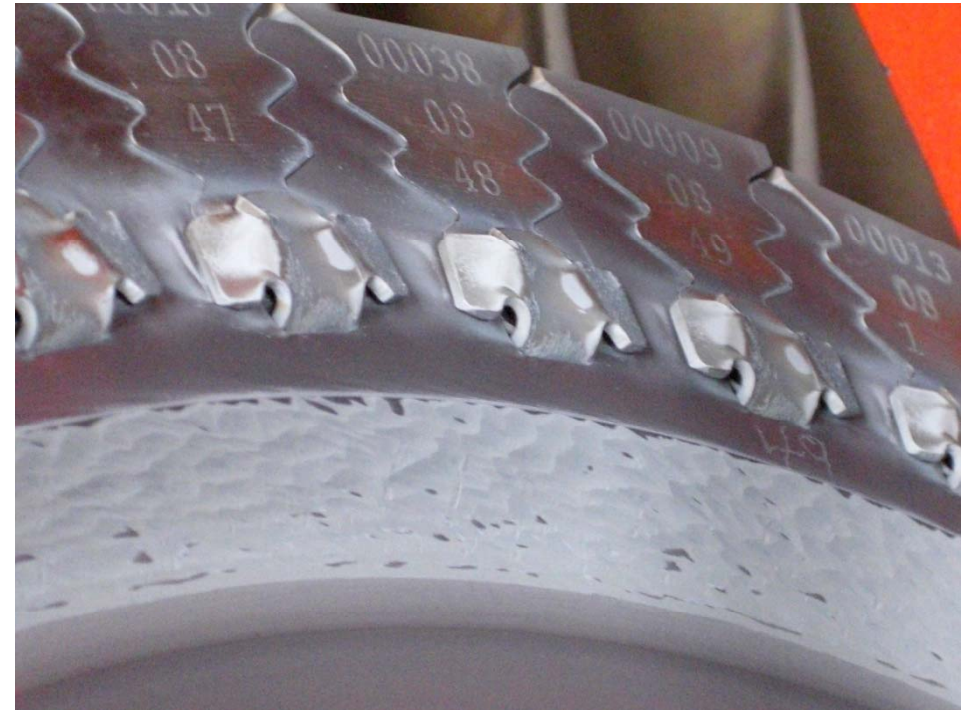
# TCA 88-25 Turbine Rotor

**TCA 88-25 extended application range with 49 blades instead of 41 blades of the smaller types**

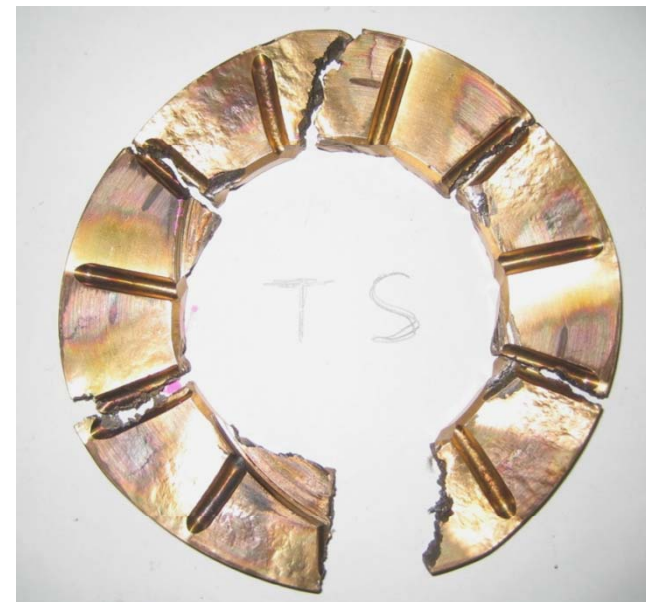
Damaged floating disc

## Service Experience

- Loosing the air cushion by permanent lubrication
- In case of black out insufficient lube oil supply
- predamaged bearings possible due to black out during sea
- in most cases the predamaged bearing fails during further operation and leads to severe T/C damage

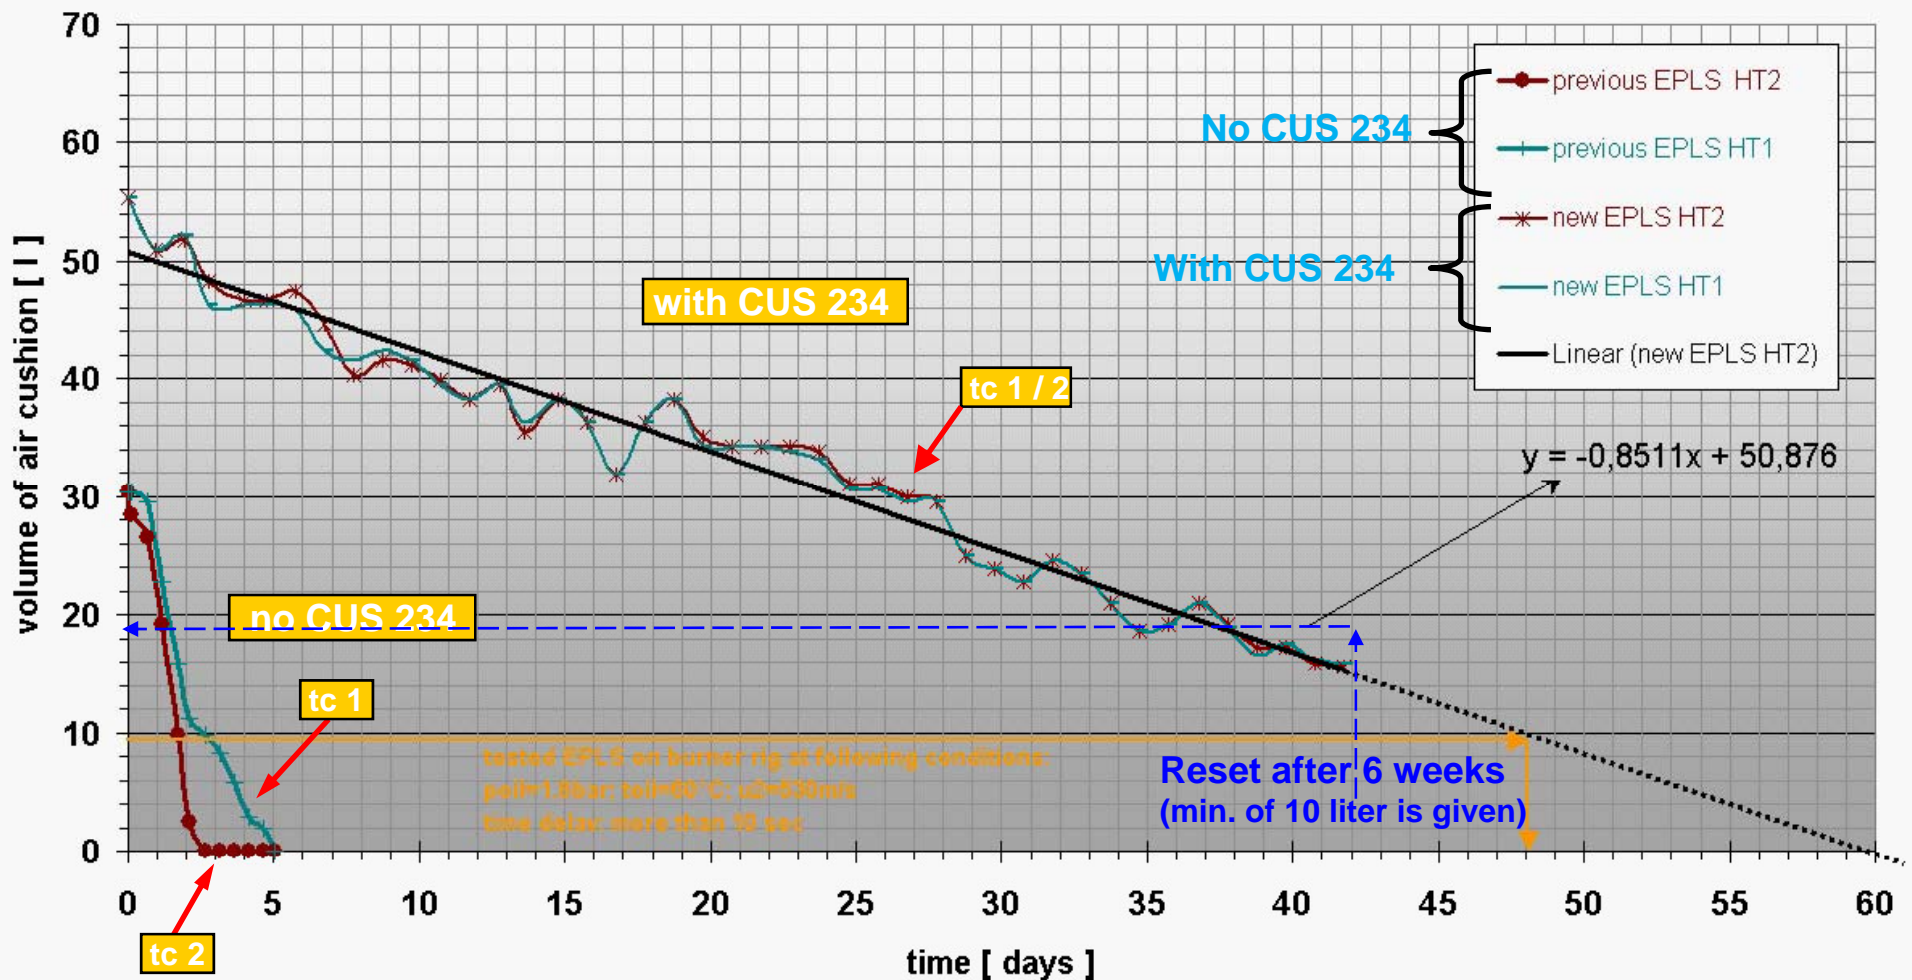
# TCA Field experience with CUS 234

continuous lubrication emergency and post lubrication tank

$p_{oil\_in}=2.2 \text{ bar}$ ,  $T_{oil\_in}=45^\circ\text{C}$

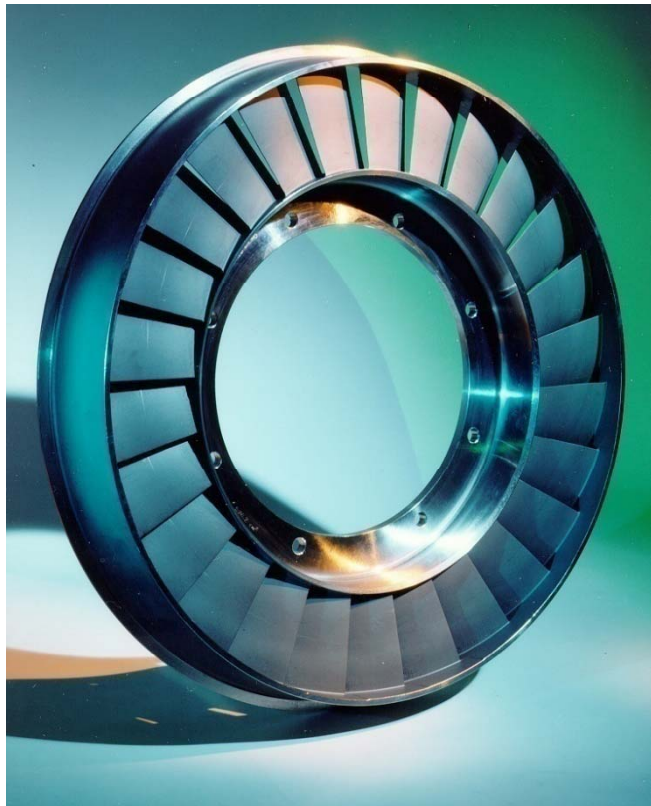
New nozzle ring has 27 vanes

**Changing the number of vanes on the nozzle ring from 26 to 27 in new TCA (since August 2006) reduces:**

- the forces on the turbine blades at least 20-30%
- changes the blades resonance frequency

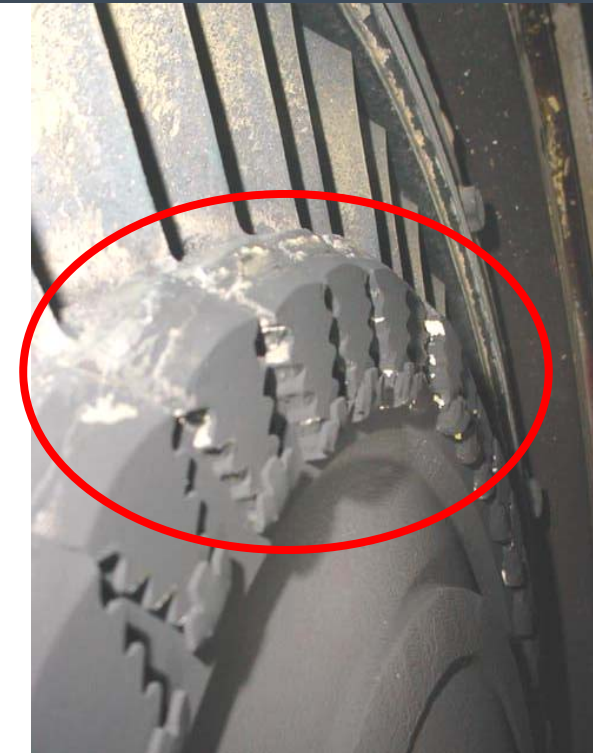
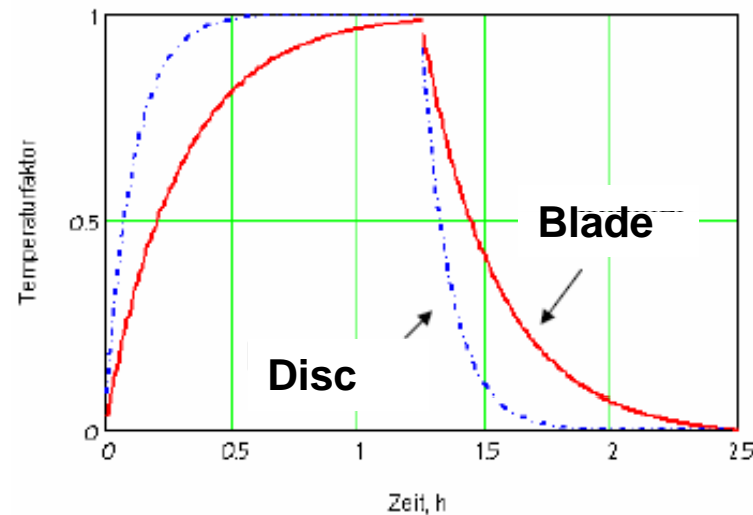
### Service experience:

- Blades move in axial direction towards admission side

### Reason:

- Load changes in part load operation
- Different temperature distribution and coefficient between turbine disc and blades

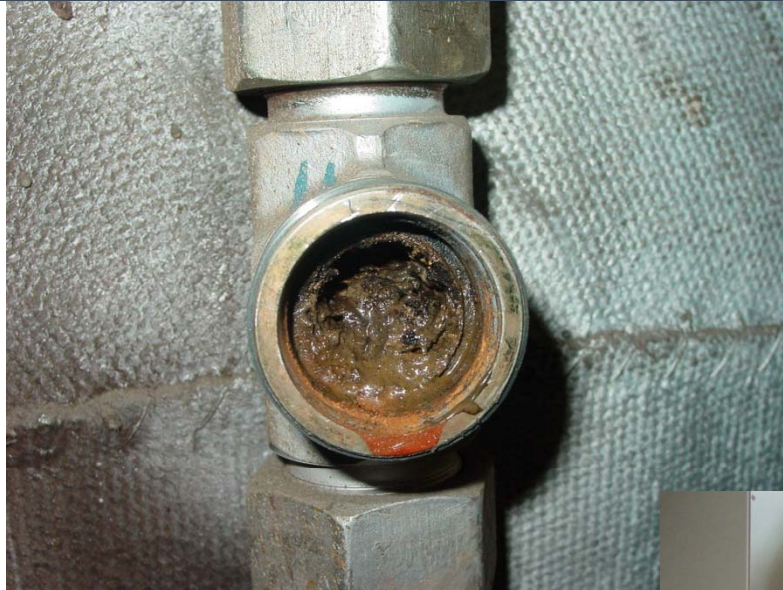
- **Blocked turbine wet cleaning**

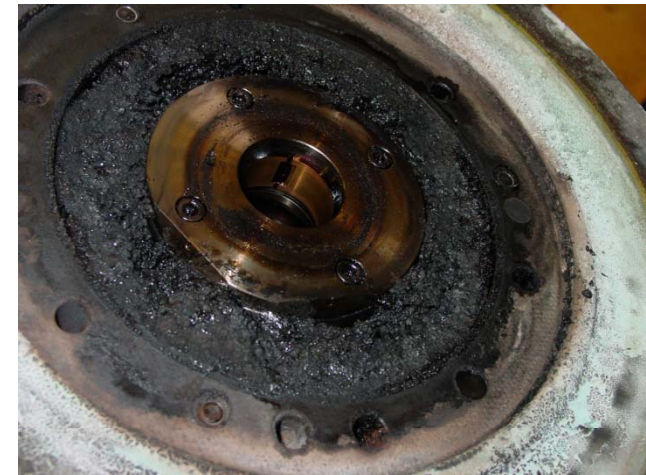
Splash oil cooling (already introduced on larger NR/S) stops coking of lube oil on turbine side in case of high operating temperatures in combination with condition and quality of the lube oil.

Lube oil is splashed into the upper area of the sealing cover (517.017) and distributed by means of a borehole in the bearing casing (517.001). The oil runs down into the lube oil drain via a U-shaped annular groove in the sealing cover. By this the surface temperature of the cover is reduced and oil coking is stopped.

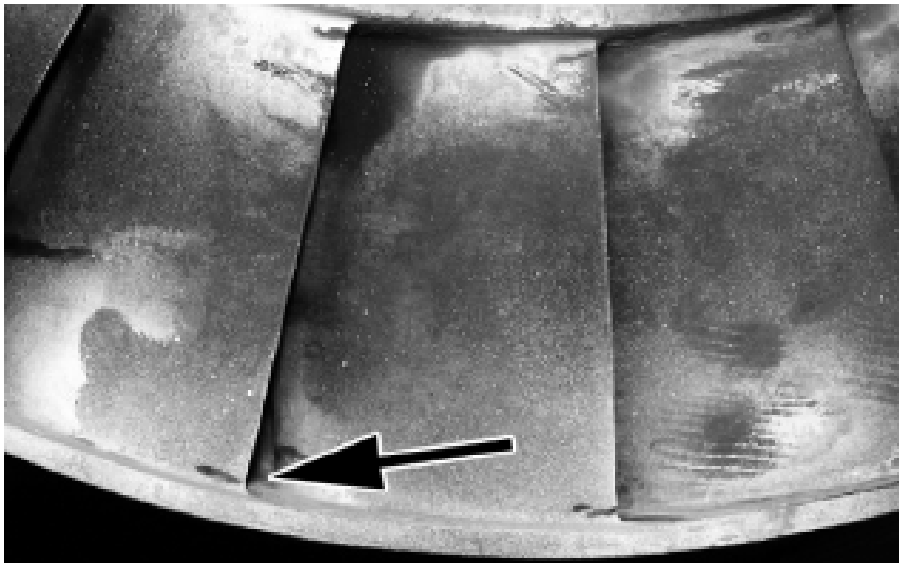
During scheduled maintenance work on NA turbochargers in the past, our MAN Diesel PrimeServ service personnel have occasionally detected the formation of cracks at the vanes (inlet side and outlet side of the vane) and at the bolt holes of cast nozzle rings.

Only nozzle rings for the following turbocharger types are affected:  
NA48/S, NA48/T, NA57/T and NA57/T9

Investigations carried out by MAN Diesel showed that the cracks had been caused by the rigid fastening of the nozzle rings in the gas-admission casings. The gas-admission casing had not been able to adequately absorb the expansion of the nozzle ring as a result of high exhaust-gas temperatures.

Nevertheless, MAN Diesel recommends its customers to check and, if necessary, replace the nozzle ring during the next scheduled turbocharger maintenance. The new nozzle rings can be mounted in the gas-admission casing without further modifications.

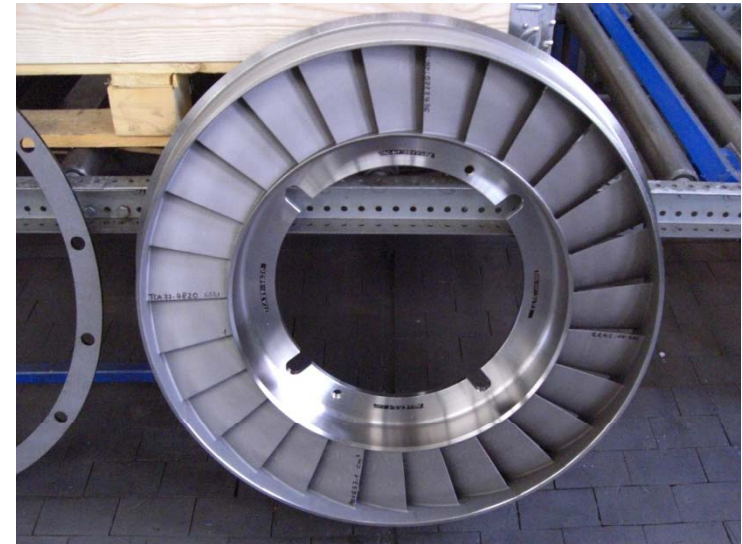
TCA nozzle ring  
modification  
similar to NA

| 1 Gas-admission casing | 5 Hexagon bolt |
| 2 Nozzle ring | 6 Hexagon bolt |
| 3 Sleeve | 7 Lock washer pair |
| 4 Lock washer pair | 8 Clamping ring |

In case of replacement orders, MAN Diesel will automatically deliver this latest design of nozzle ring with the associated fastening materials.
