# Key Components, Tegholmen Works

## MC fuel pump

# Latest Design for 80-98 bore MC/-C engines

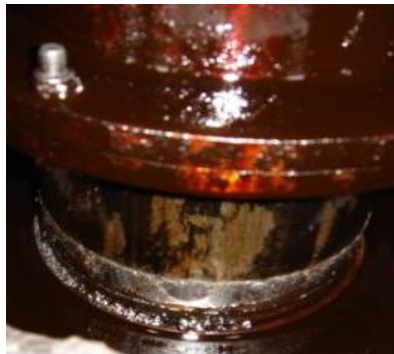
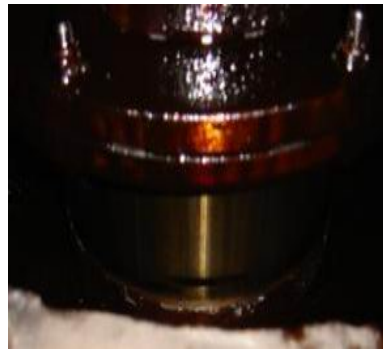
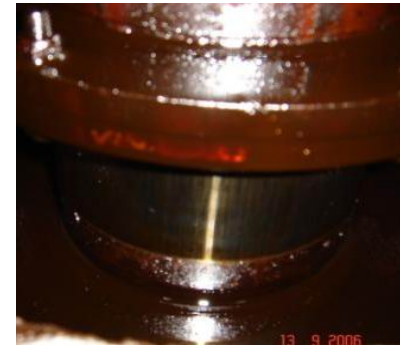
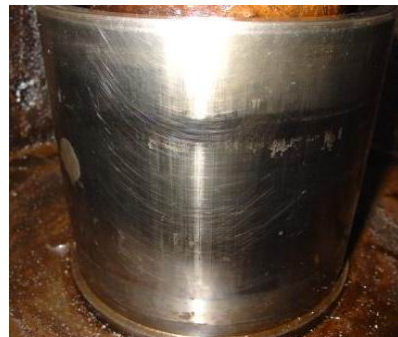
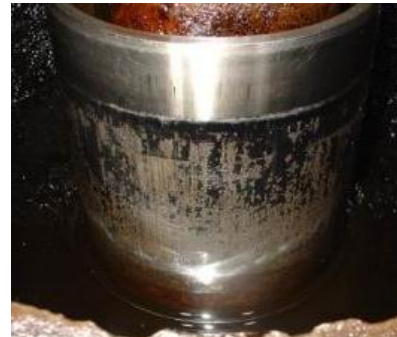
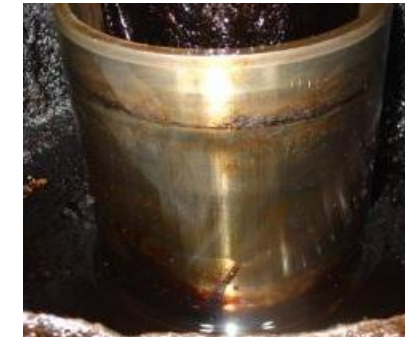
# Facts from a 6S60MC engine (33352 running hours)

Radial wear of the axial scraper ring was pronounced for 2 out of 3 inspected fuel pump units

The sleeve is shrink fitted in the pump base block. In rare cases the fit has been insufficient with the consequence, that the sleeve has been lifted. If the lift has reduced the 9 mm distance to zero an upwards force acting on the umbrella body (red arrow) will cause fatigue breakage of the umbrella top plate

- Scheduled inspection of the umbrella assembly (fatigue cracks etc.) and the sleeve (correct shrink fit)
- Scheduled inspection/replacement of umbrella scraper rings

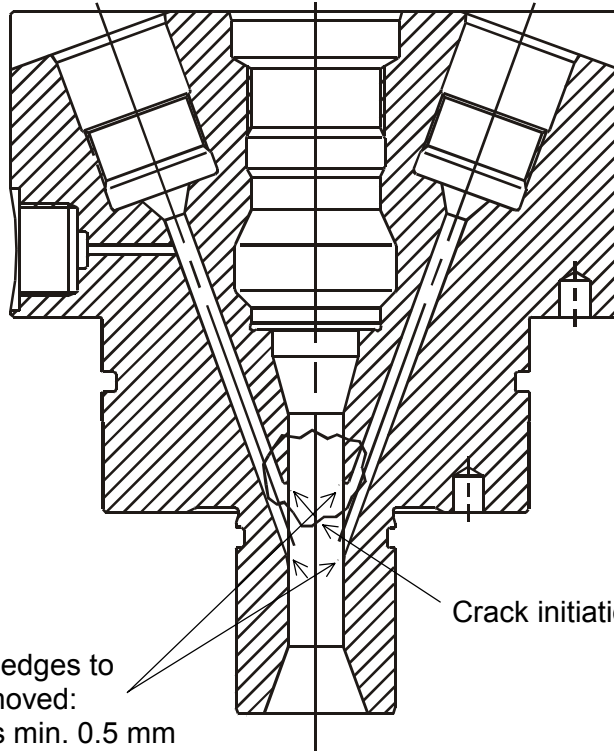
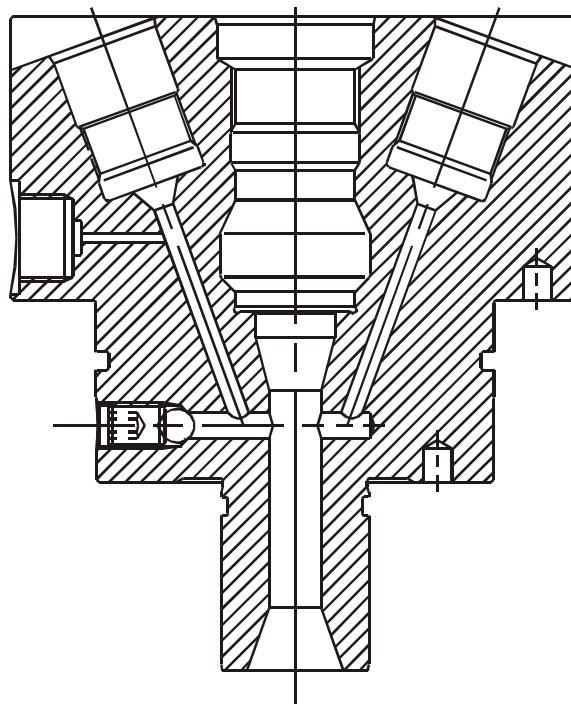
### Fuel Pump Top Cover

Crack initiation area

The fractures have been experienced on small and medium bore engines. The fractures were initiated at the position where the inclined drillings for the high-pressure pipes intersect with the central bore. The cause of the failure has in all cases been related to roundings which did not fulfil our specifications.

The cracks are initiated at the edge between the central bore and the inclined bores, due to the lack of the specified manual finishing of the transition edge between the central bore and the inclined bore. The crack-initiated area is shown in Fig. 1.

We have noted that, in each case, the crack has developed into the bore for the suction valve, whereby high-pressure fuel is pumped into the low-pressure chamber. This reduces the fuel injection pressure, and the alarm for low exhaust gas temperature will be sounded so that the crew has the possibility of correcting the failure. We have not received any reports of cracks developing in such a way that fuel leaks out into the engine room.

We recommend checking whether the spare cover is of the original design. If this is the case, please check the transition between the vertical bore and the inclined bores. The transition area must have a radius of min. 0.5 mm. On the spare top cover, the sharp edge must be removed and a rounding of min 0.5 mm must be made.

We consider that removing the sharp edge, as described, will rectify the cover, thus we recommend that you keep two spare covers on board.

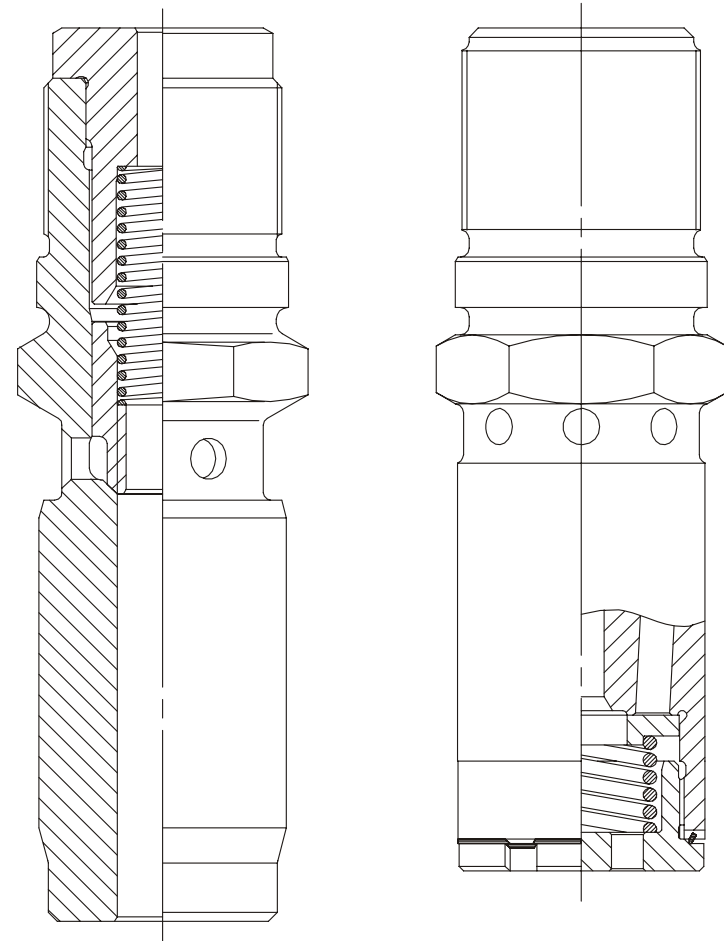
Fuel pump suction valve

We have recently experienced incidents in which damage has occurred to the sealing ring on the fuel pump suction valve slide.

As a damaged sealing ring might lead to malfunctioning of the suction valve, we have made investigations and tests on suction valves without a sealing ring.

The results of these tests revealed that the suction valve can operate satisfactorily without the sealing ring, and we therefore recommend that the sealing ring be removed at the next suction valve overhaul.
